Stabilization of ravines, adjacent beaches, and bluffs on Lake Michigan

ABSTRACT

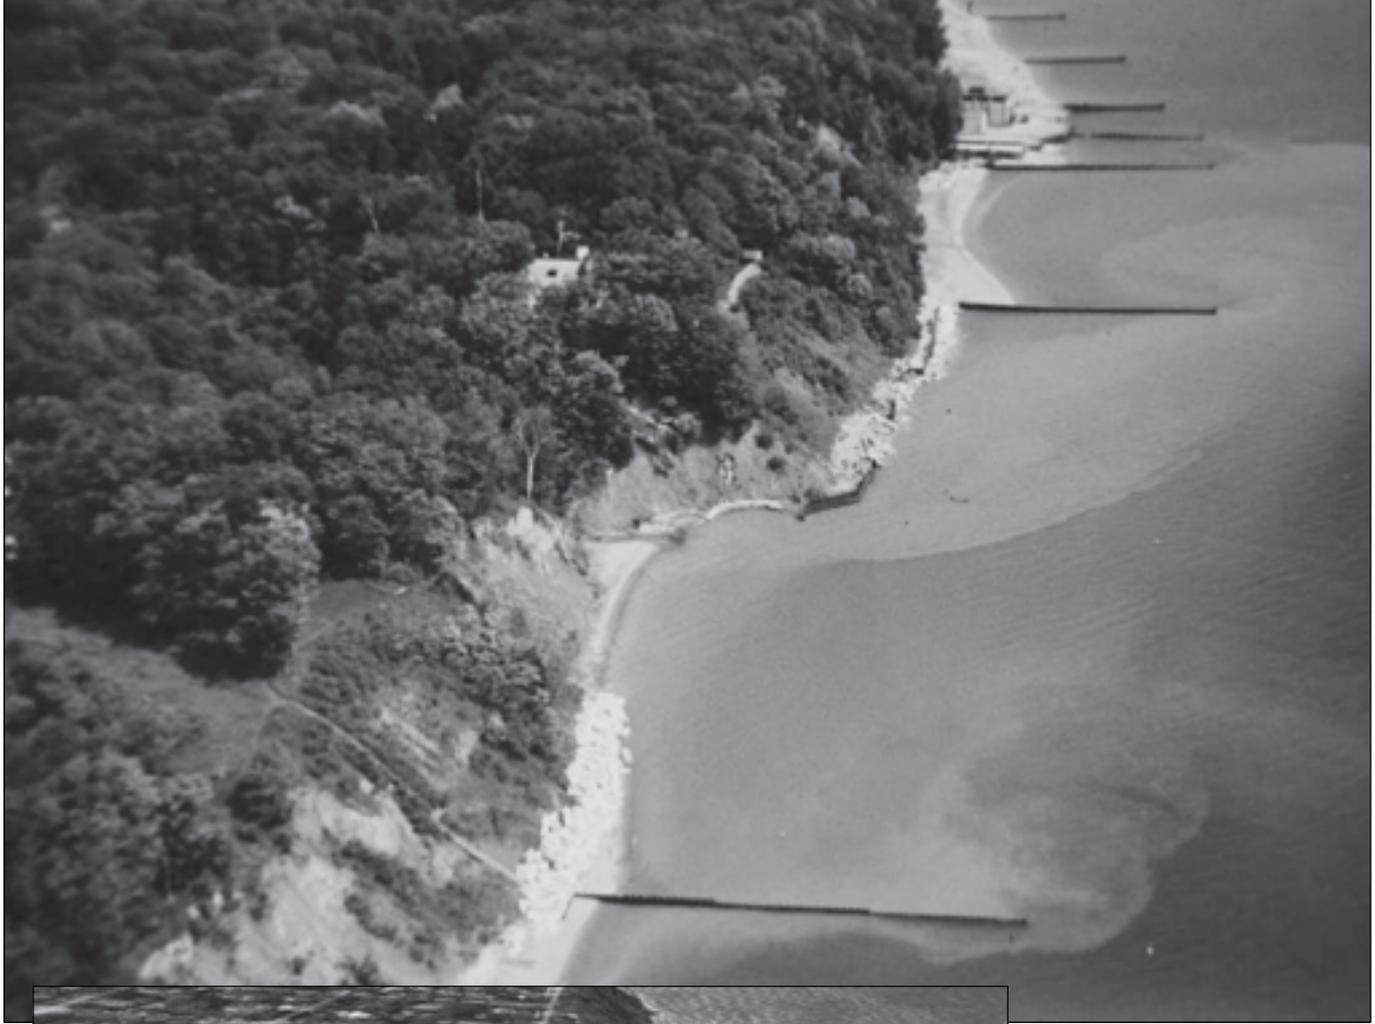
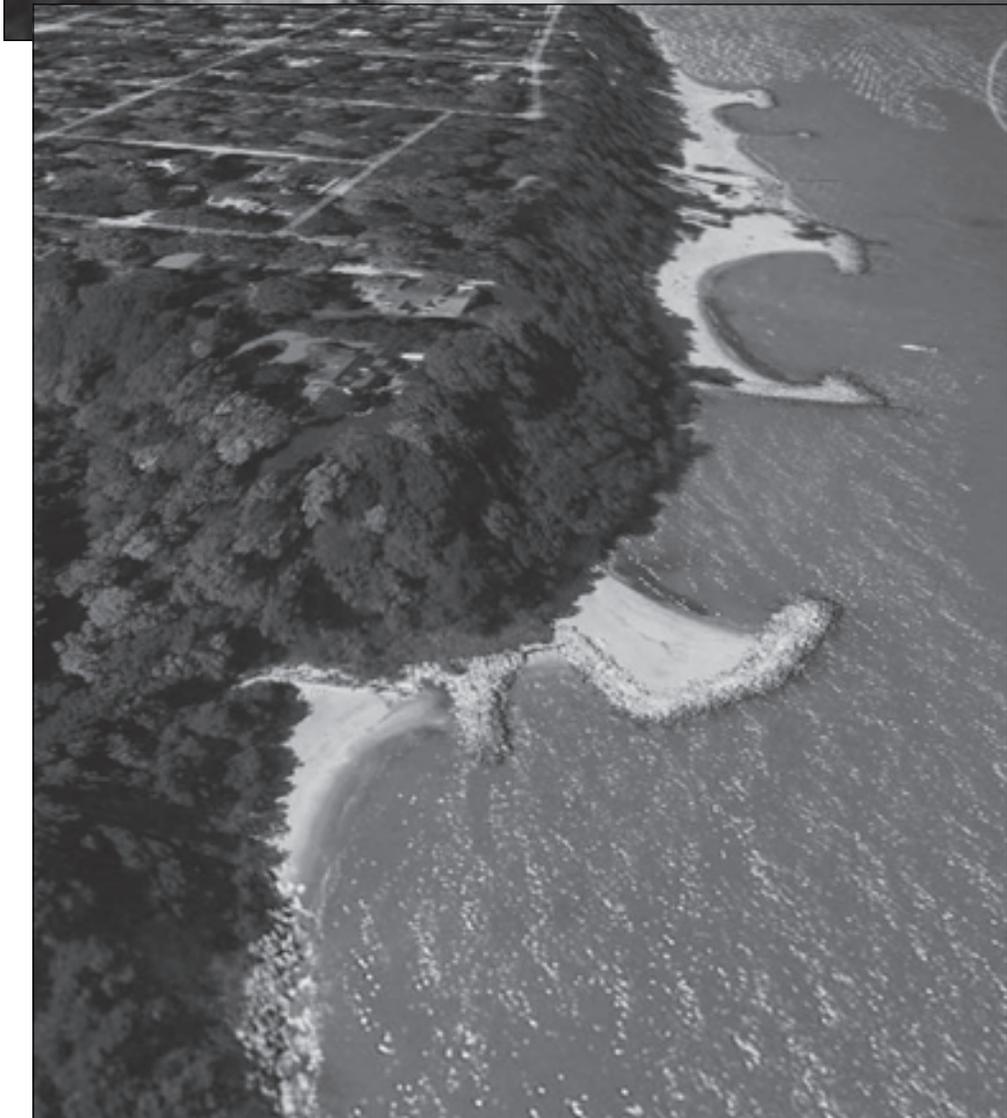
**Figure 2. Lake Bluff Ravine
Park Ravine. Mouth of
ravine and lakeshore prior
to (1990, above) and after
ravine and beach restoration
(2009 Google photo, left).
Note sediment plume from
eroding ravine and adjacent
bluffs. The pocket beach and
wetland protecting the ravine
mouth lie at the downdrift
end of a series of pocket
beaches that have replaced
the poorly functioning groin
field.**

The ravine studied in Lake Bluff is about 3,450 feet in length and runs through Ravine Park from the approximate center of town southeast, then across a new pocket beach into Lake Michigan (Figure 2). Active streambed erosion (incision), streambank erosion and mass wasting (slumps, and soil creep) was observed in most locations along the axis of this ravine. Prior to restoration, the mouth of the ravine was bordered by eroding lake bluffs and failed seawalls; no beach was present. In 1992, in response to requests from ravine property owners, deteriorated natural streambed armor

Prior to ravine restoration, the mouth of Ravine Park Ravine was flanked with eroding coastal bluffs, failed seawalls and a small ephemeral pocket beach (Figure 2). Beginning in 1990, the bluffs were stabilized with rubble fill, covered with soil and hydroseeded (Figure 7). Later, a larger, more stable pocket beach was established behind a stone headland breakwater to provide a higher level of protection for the ravine mouth (Figures 2, 7, 8). A total of 1,000 tons of sand fill was added to the beach, with all work completed by 2003.

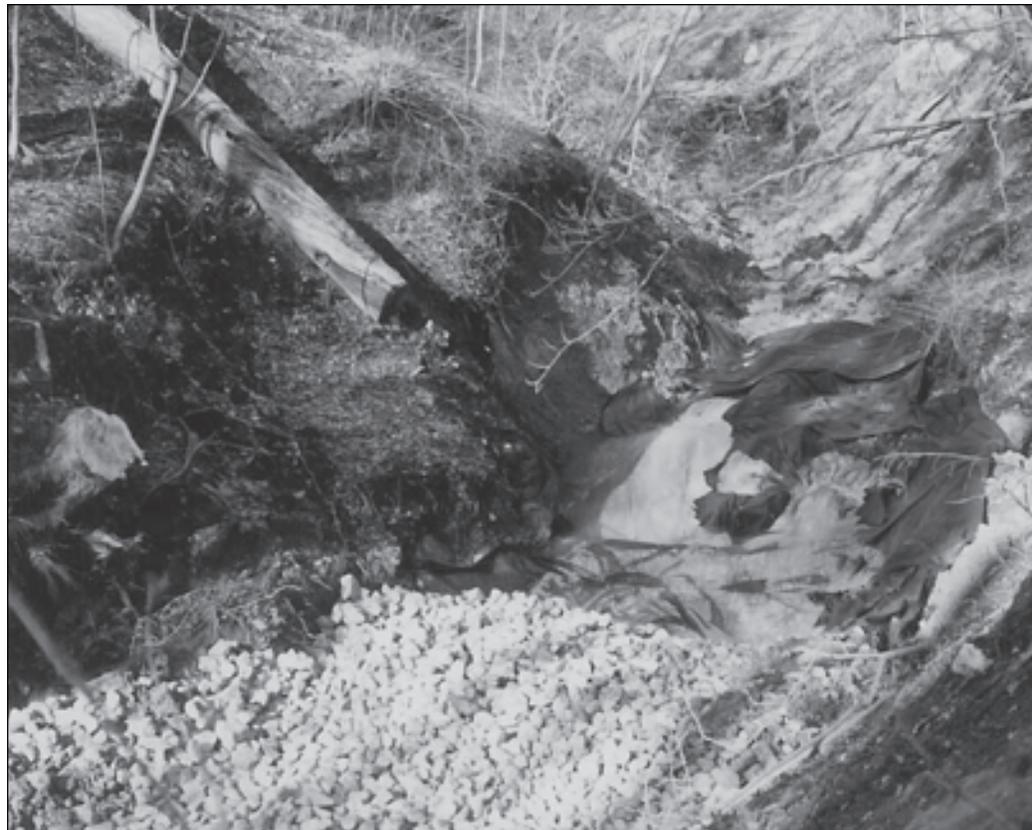
Figure 4. Ravine Park Ravine streambed and banks repaired with a 3-foot-thick layer of 6-inch to 12-inch limestone (stream armor) over geotextile (1992 photo). Concurrently, slumps were filled with limestone and concrete rubble and covered with hydroseeded soil. A subsequent survey showed that it took approximately one year for the void space between the new stream cobbles to fill with sand and gravel eroded from upstream slumps.

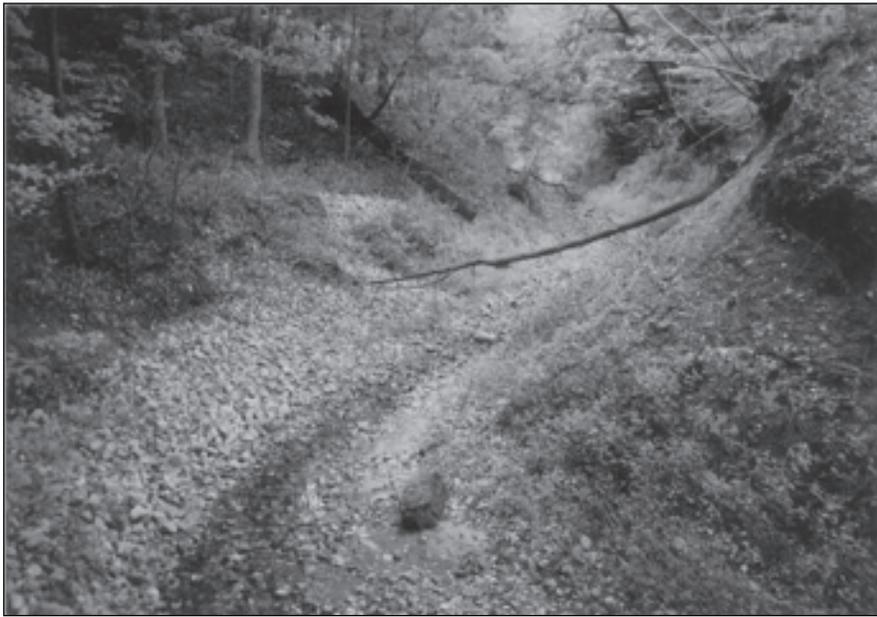
Figure 5. Ravine Park Ravine four years after construction. Stream flow is now visible on the surface. In prior years, the water flowed below the top of the stone work. Note encroachment of vegetation over the new stone and steep slope on right that has not fully vegetated.

In 1992, irregularities in the streambed were graded to a uniform slope with a bulldozer. Geotextile was placed in the streambed and lapped up onto the sides of the ravine from 3 to 10 feet in areas where the streambanks had slumped. A three-foot-thick layer of quarried “limestone” (dolomite) was placed over the geotextile. No grade control structures were installed. The slumps were filled with rubble and quarrystone, top-dressed with soil, and hydroseeded with temporary annual grasses. The local vegetation was then allowed to reestablish itself on the slumps and the restored ravine banks (Figures 5, 6). Maintenance activities

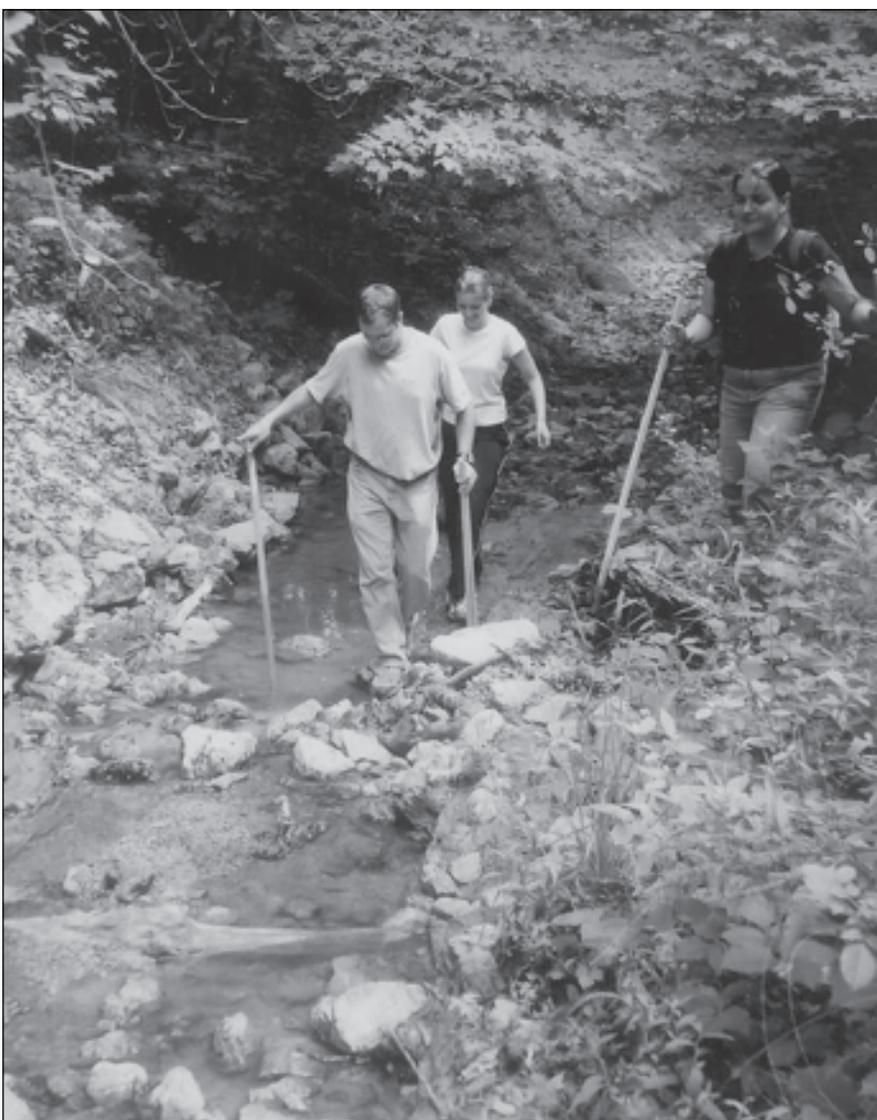
Figure 6. Ravine Park Ravine 13 years after construction with fully established vegetation. Sand and silt from the eroding upstream section of the ravine has filled the interstices of the stone in the ravine bed. Note 12-inch to 24-inch stones forming natural weir (check dam).

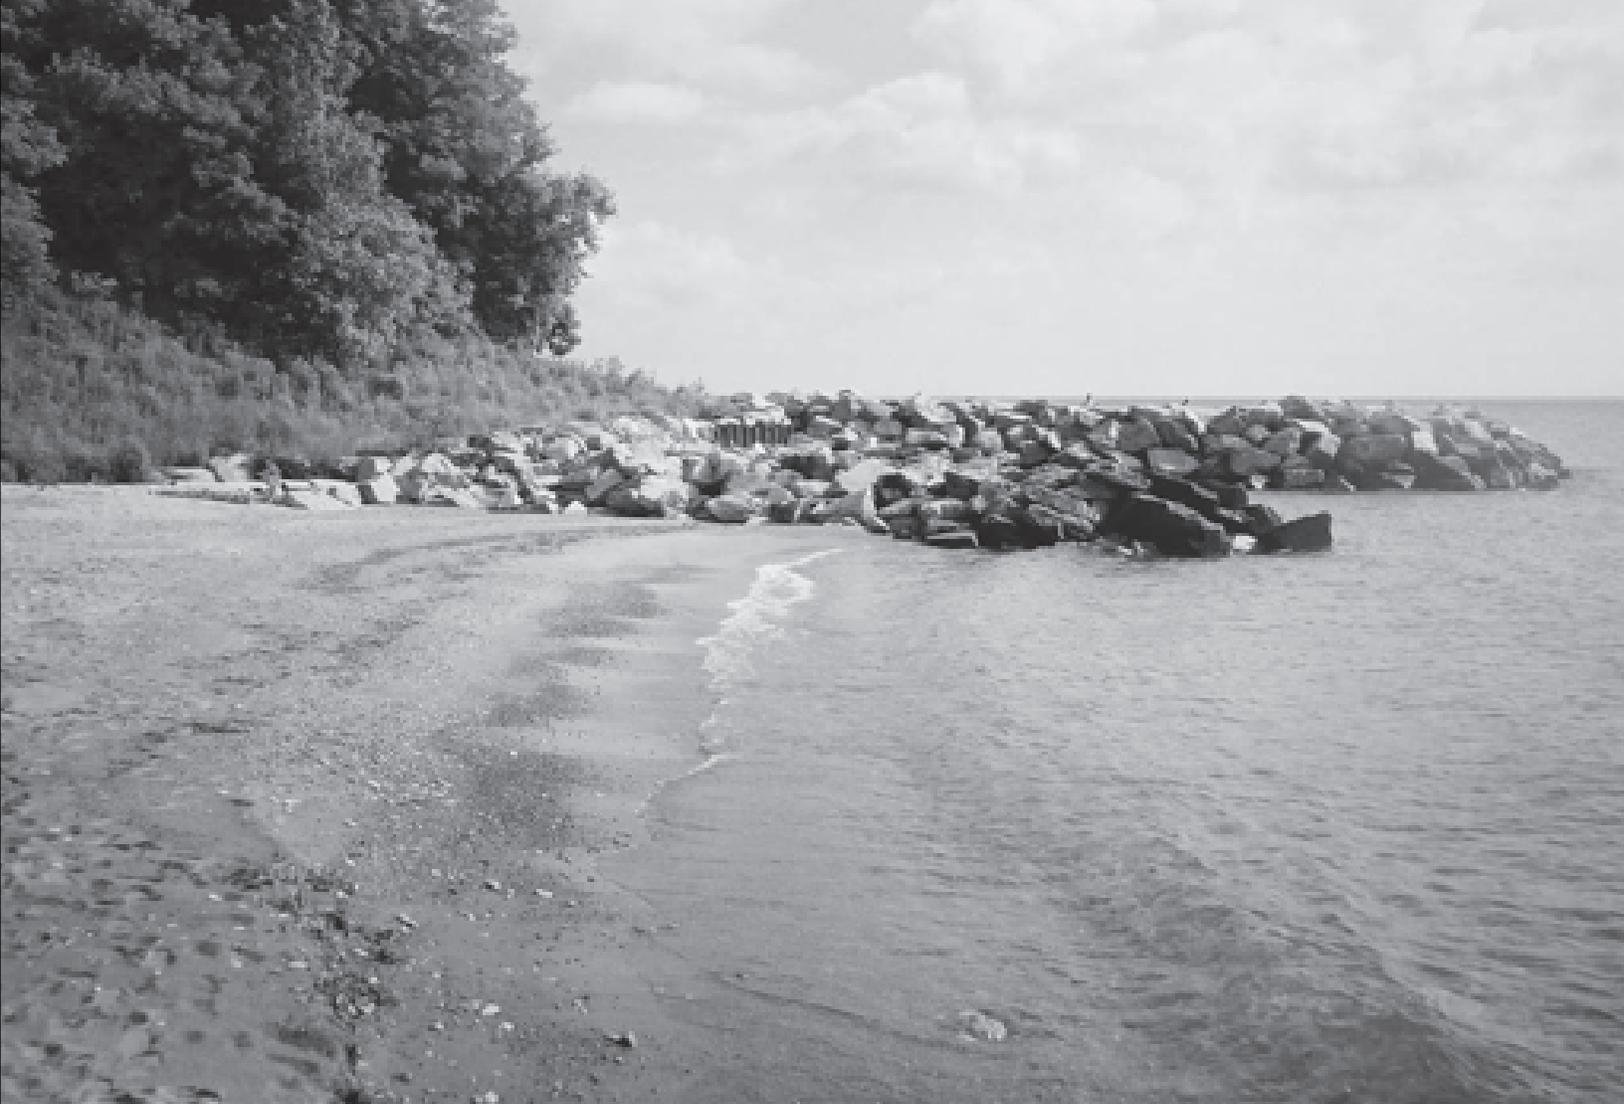
Figure 7. Newly constructed pocket beach at mouth of Ravine Park Ravine, Lake Bluff (2007 photo). Note well established vegetation on bluff stabilized in 1990. Periodic air photo surveys show the beach to be stable with no negative impacts on adjacent beaches.

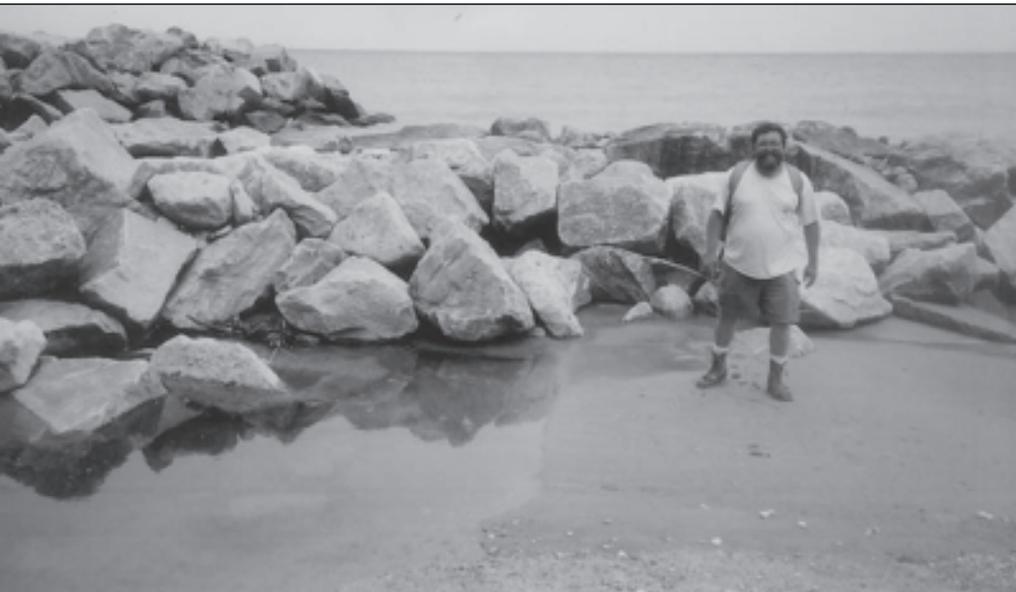
Figure 8. Close-up of ponded ravine water in pocket beach at mouth of Ravine Park Ravine. During low-flow conditions, the ravine water is filtered through the sand beach. Unidentified species of algae have taken up residence in the pond.

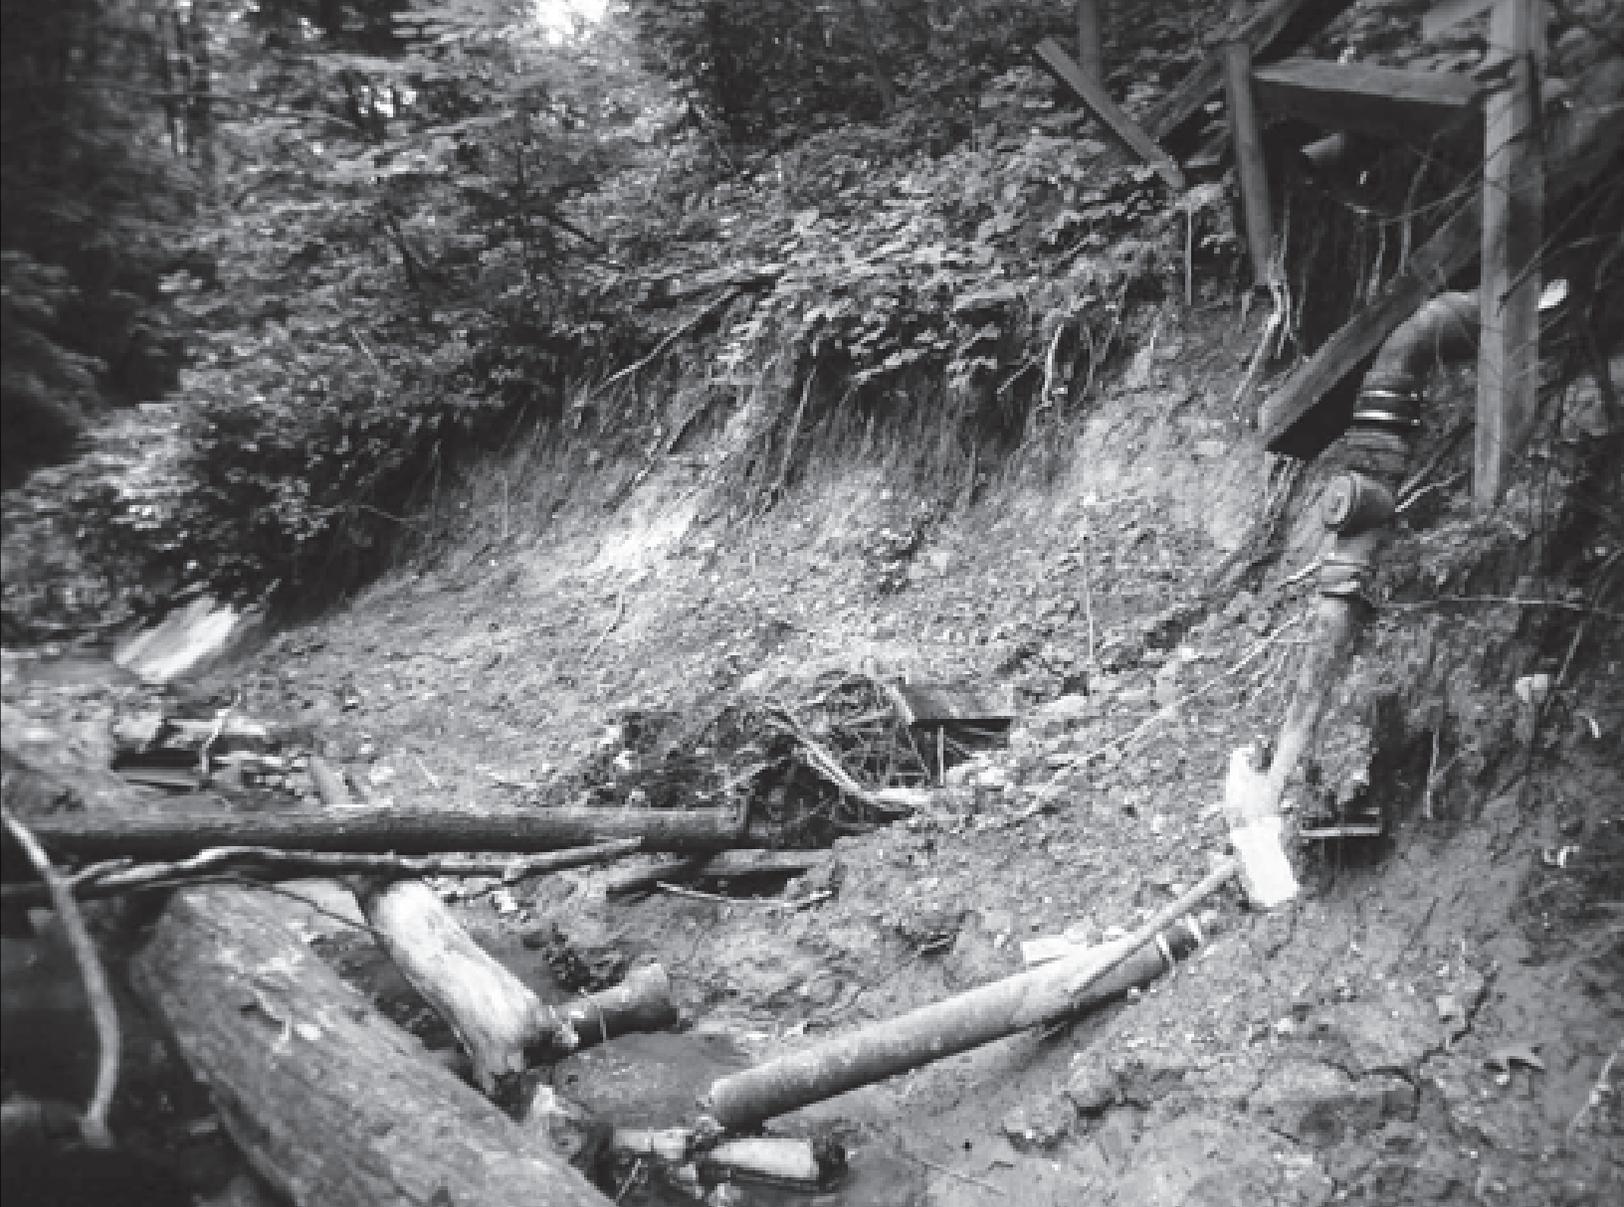
Figure 10. Ravine 10, city of Highland Park, Illinois. Unrestored ravine with active streambed erosion and slope failure. Broken sanitary sewer can be seen at the lower center (1992 photo).

aged sanitary sewer connections were observed in many locations along the axis of this ravine in 1992 (Figure 10). The study site includes approximately 900 feet of ravine beginning at the head of the ravine. Here, the average ravine slope is 1:53, a slightly lower slope than the stream gradient of 1:42 at Ravine Park Ravine in Lake Bluff.

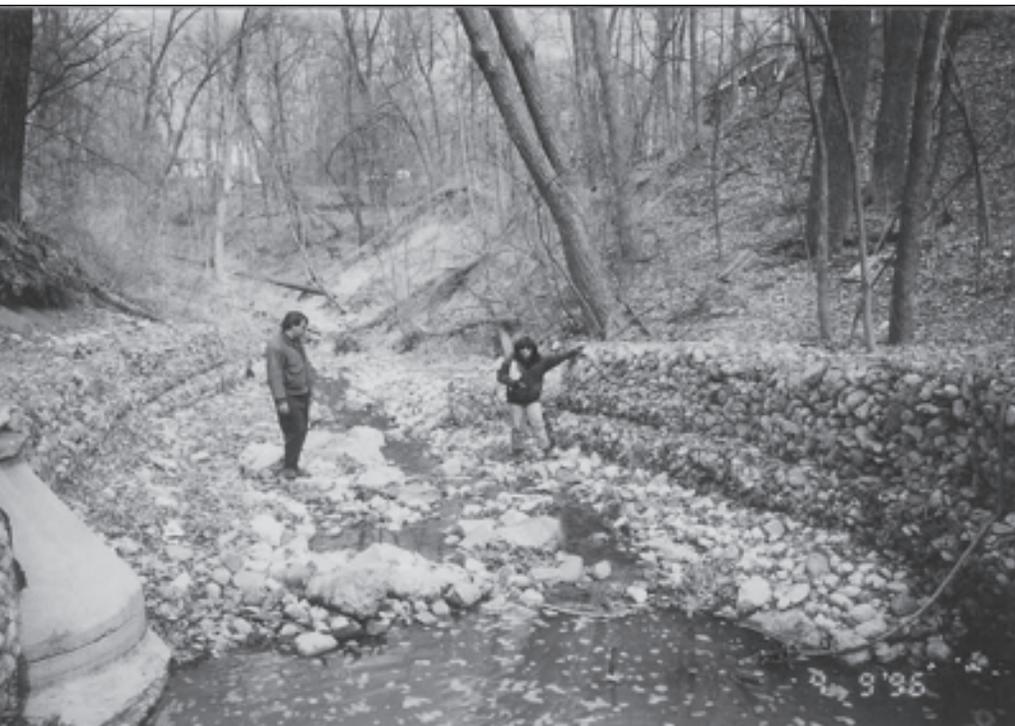
Figure 13 (bottom). After 15 years, gabion baskets are intact but are undermined due to scour of stream armor (too small for flow conditions) and lack of foundation stone. Outfall concrete apron to left (2007 photo).

sided visibly from their original position (Figure 13). The existing streambed armorstone was not large enough to remain stable during peak-flow conditions and had washed downstream. The gabions also appear to have confined the flow in the ravine, thus increasing its velocity and erosive power. The area of greatest erosion in the study site lies within a short distance downstream from the gabions. A preferred alternative to gabions at an outfall is a system of large river stones and a large plunge pool (Figure 14).

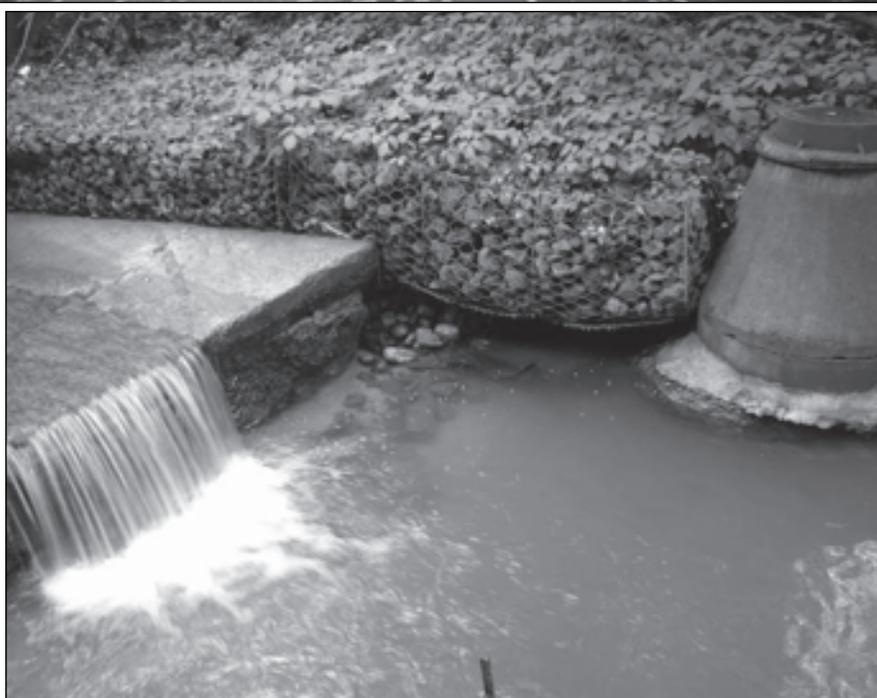
Figure 14. A plunge pool protected by the proper size boulders makes a more natural energy dissipator at a stormwater outfall than one protected by gabions.

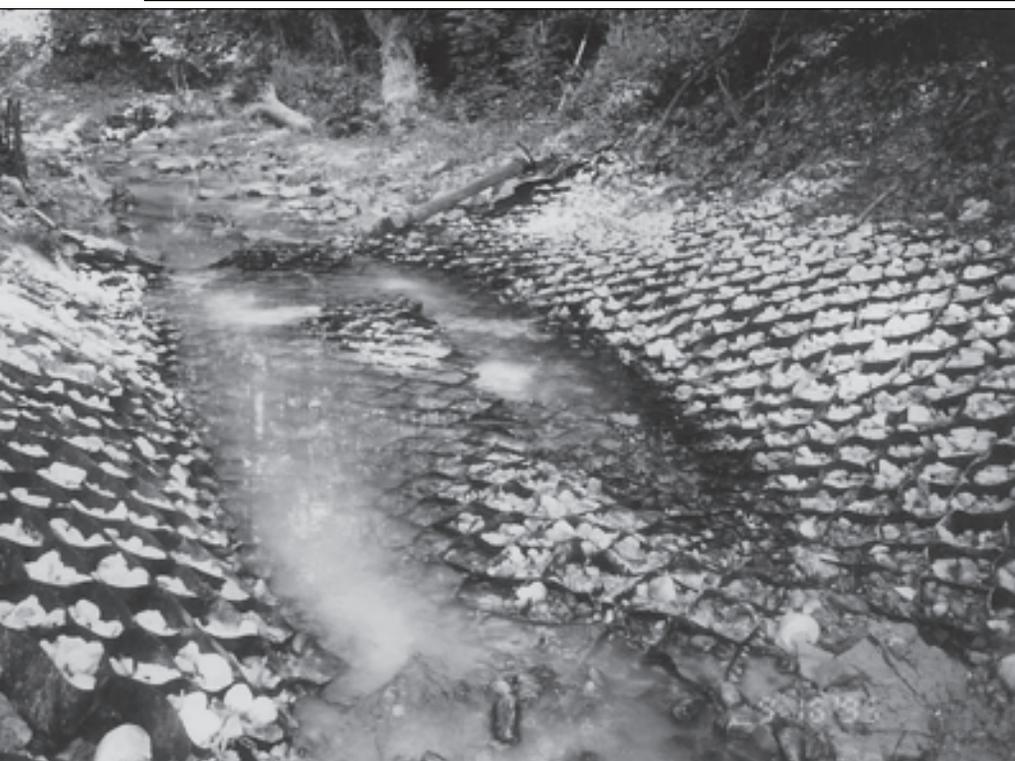
Figure 19 (bottom). Geoweb streambank and streambed armor in Ravine 10 (1996 Photo). After streambed and banks were graded, the plastic webbing was installed and filled with 3-inch "limestone" (dolomite).

Geoweb — Geoweb is a plastic textile that is “honeycombed” to allow cobblestones to fill the voids and hold the material in place. Installation was in areas of actively eroding clay in the streambed. After the clay was graded with a bulldozer, the Geoweb was placed directly on the streambed and extended approximately 3 feet up both sides of the ravine. 3-inch quarried “limestone” (dolomite) was placed in the voids immediately after installation (Figures 18, 19). Geoweb plastic showed some signs of deterioration and minor stone loss, but was sufficiently intact in 2007 to function in retarding downcutting (Figure 20). In a manner similar to that of the Reno mattress, the Geoweb is subject to flanking and also acts as a check dam, concentrating energy downstream. Note loss of stream armor downstream.

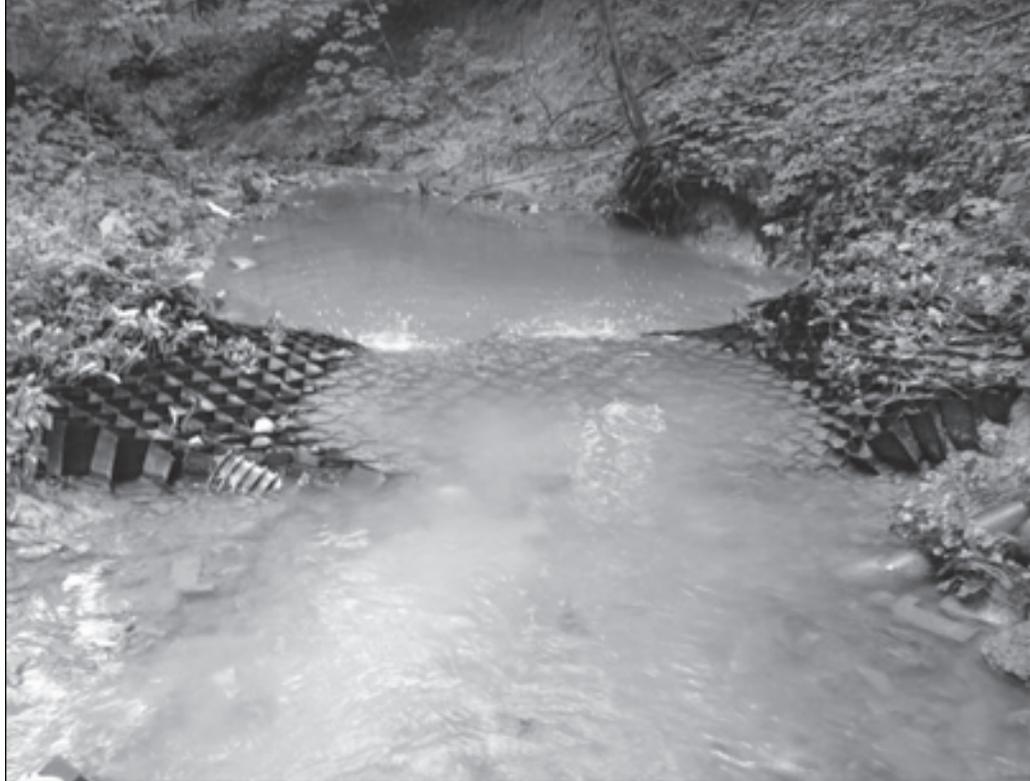
Figure 20. Geoweb armor intact in 2007. Note loss of natural streambed armor and fill-stone.

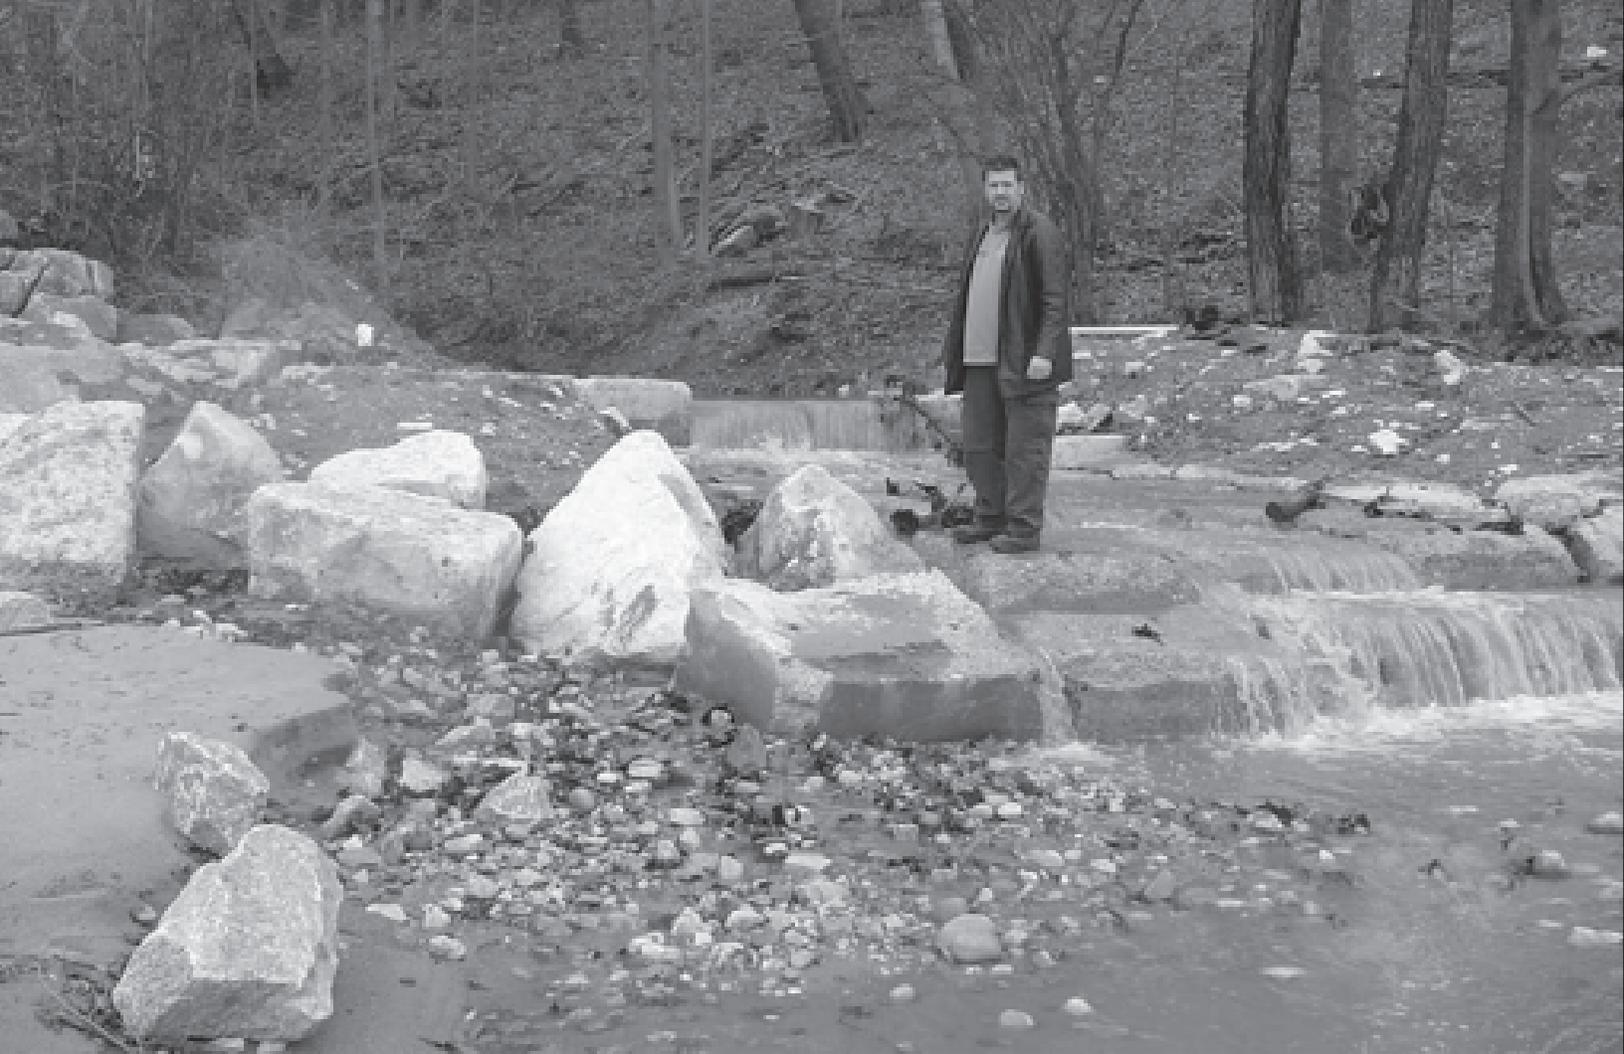
Figure 22. Glencoe Ravine. Newly constructed east check dam after rainstorm (3 May 2004 photo). Falls have added benefit of aerating the stream water.

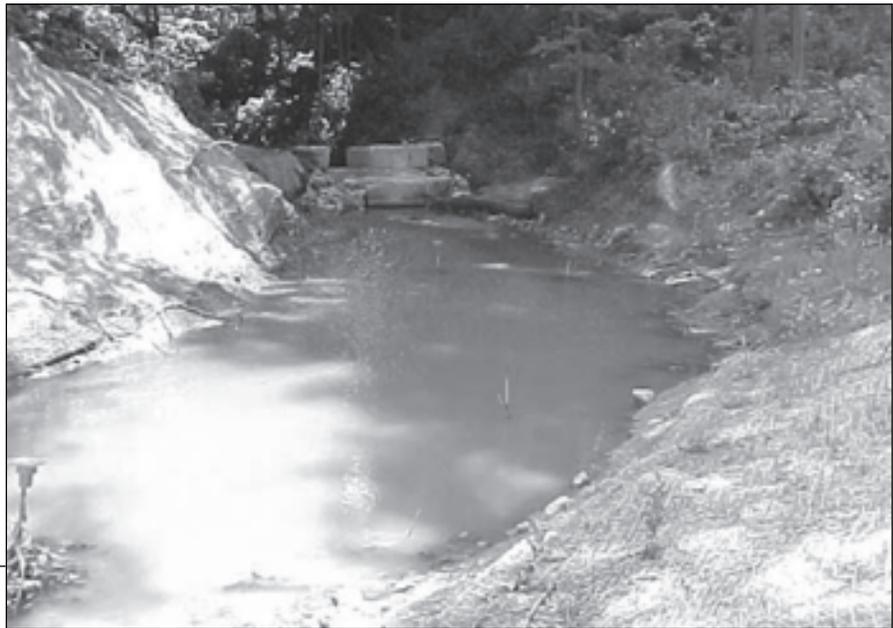
Figure 24 (middle). Glencoe Ravine mouth (immediately left of stone groin), prior to installation of retention basins and beach (2000 photo).

In 2003, a quarystone breakwater and 3,000 tons of clean sand were installed to create a stable sand beach at the ravine mouth. The project was funded by the adjacent property owner who also contributed to the local cost-share for the ravine restoration and project monitoring (Figures 24, 25). Beginning in 2005, ravine, beach and lake shallows were monitored for bacterial content at the Glencoe and Lake Bluff Ravine sites. This research was supported by a grant from the Great Lakes Commission. Six water sampling sites were established including an upper unrestored section and two sites within the restored ravine stream channel. Ravines were also inspected for broken or leaking sanitary sewers. Three samples were collected in the beaches including ponded areas at the mouth of the ravines and two from shallow pits dug into the beach sand. One sample was collected in the adjacent swash zone in Lake Michigan. The sites were sampled randomly at two-week to three-week intervals in 2005 and 2006 for a total of seven fall visits

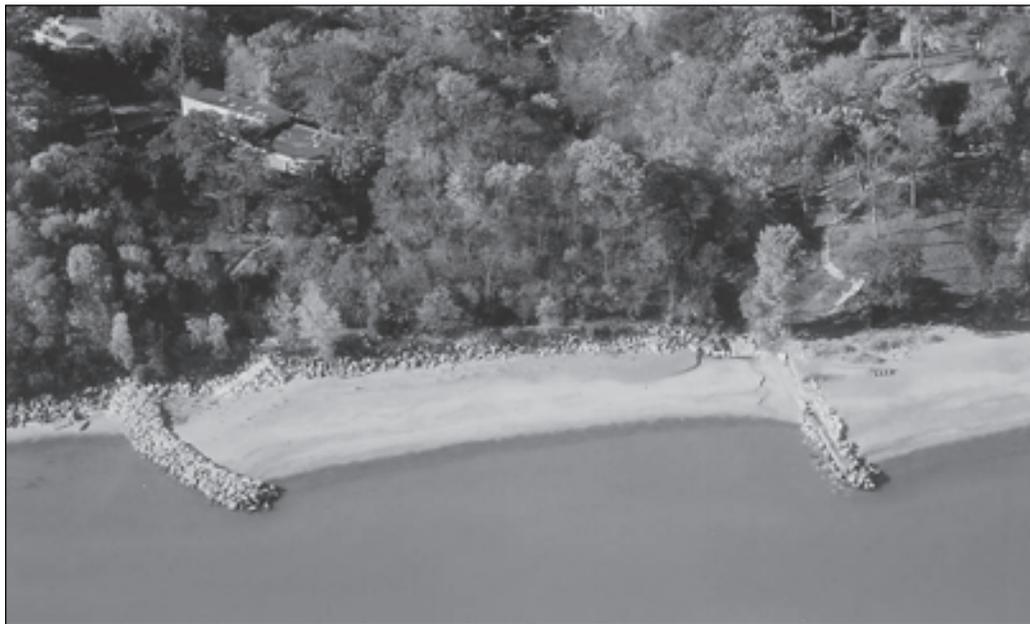
Figure 25 (bottom). Glencoe Ravine mouth with new check dam and new beach/wetland filter system. New stone breakwater on left. Note healed scour channels adjacent to ravine mouth (2007 photo).

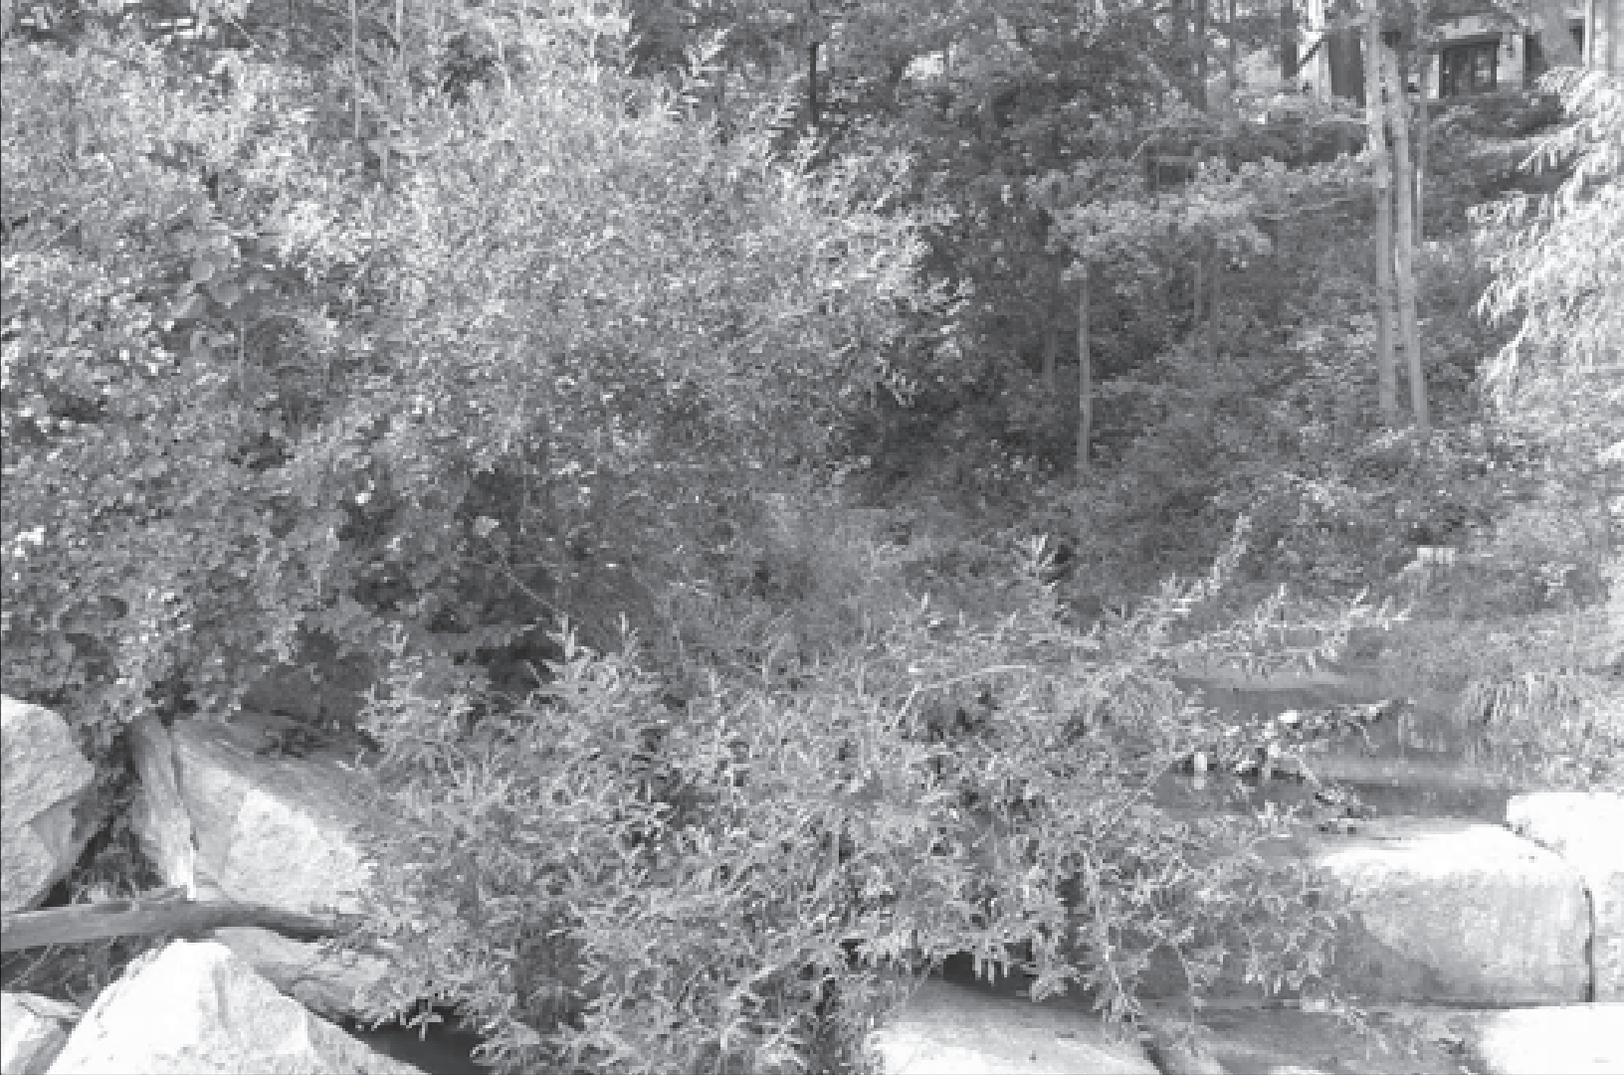
Figure 28. Fully vegetated streambanks and check dam at mouth of Glencoe Ravine (2007 photo).

In summary, the check dams filled with sediment, upstream banks have been stabilized, seeds germinated, and new vegetation is growing well (Figures 28, 29), though the large quantity of sediment eroded from the upper reaches of the ravine was not fully anticipated. Incipient flanking downstream from the upper check dam began during an intense rainstorm (Figure 30) and should be repaired as soon as possible. Monitoring of ravine water shows increased levels of *E. coli*, especially after rainstorm events, although no evidence of broken or leaking sanitary sewers was observed.

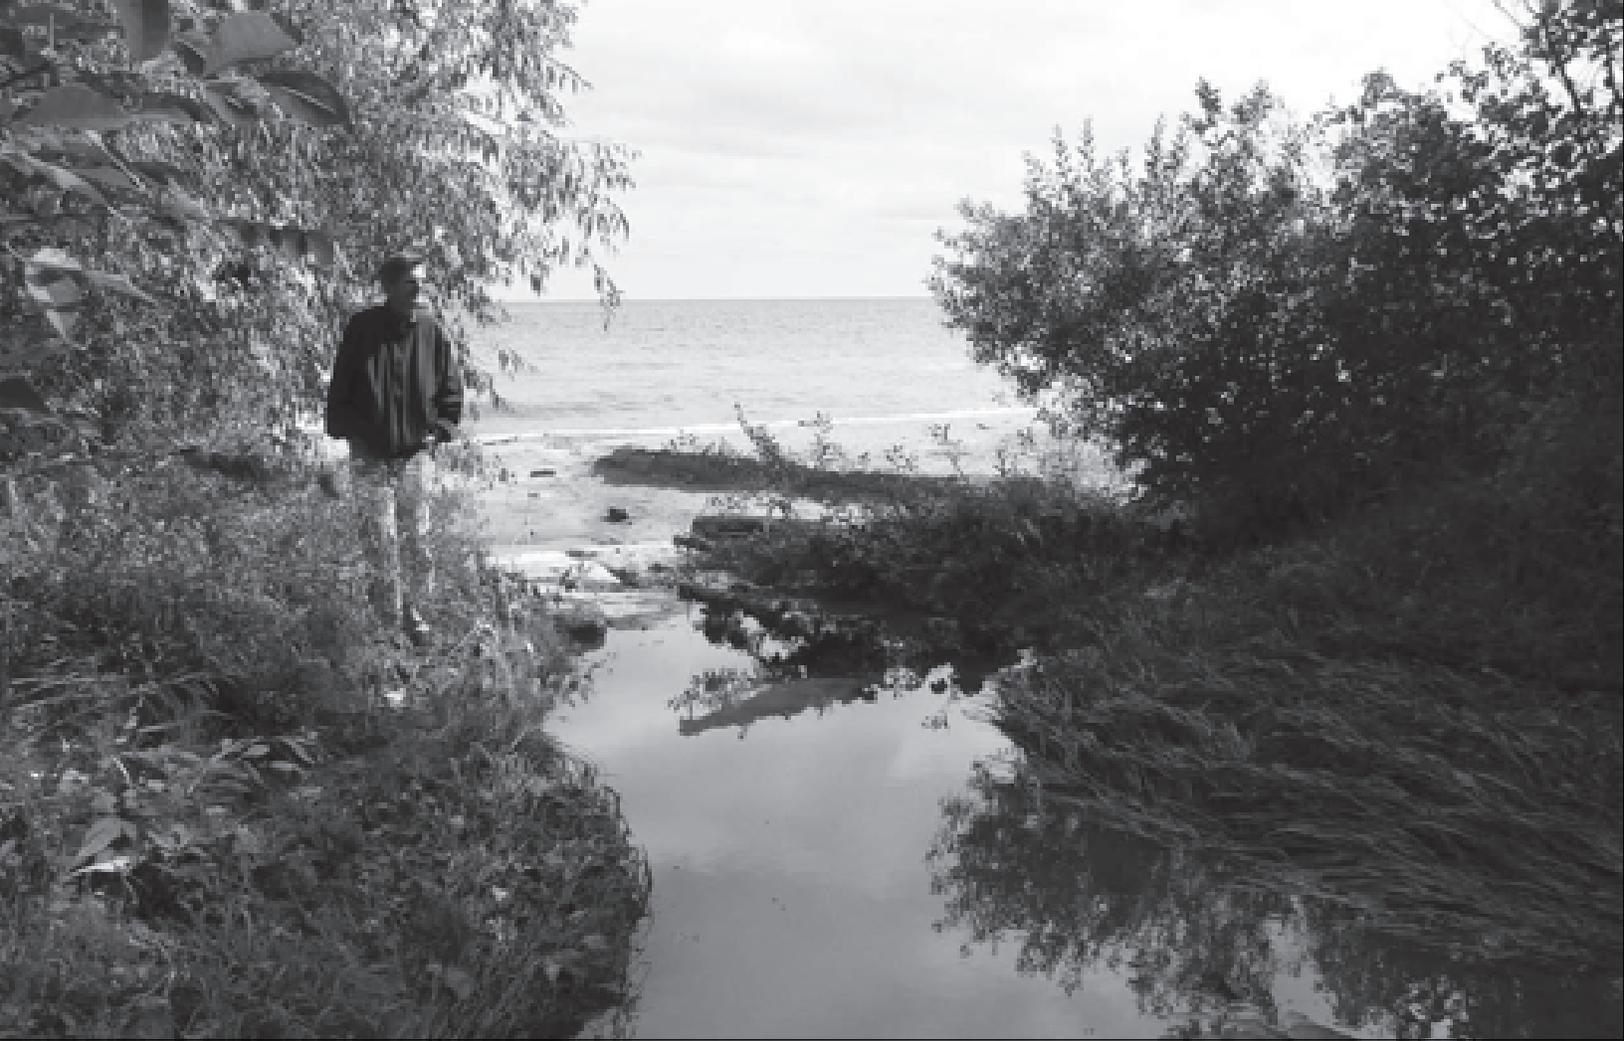
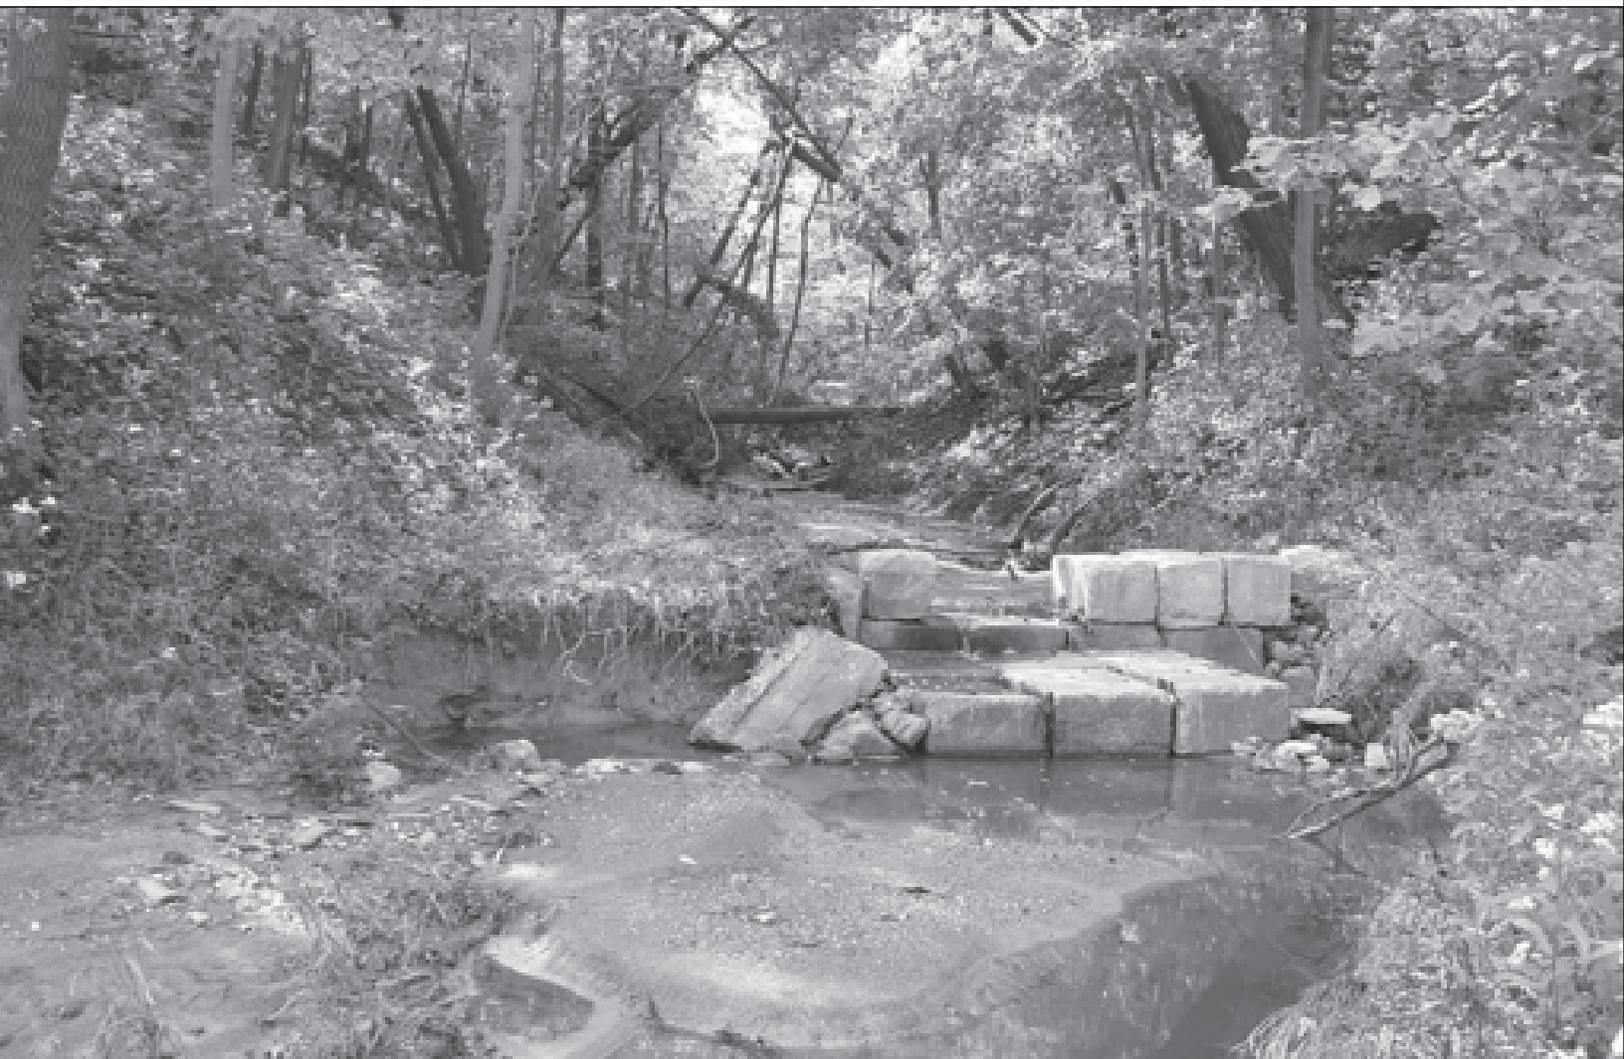
Figure 31 (above). Foss Park, city of North Chicago, bluff and beach restoration project sponsored by NOAA and Illinois Department of Natural Resources.

lic park and beach located along the western shore of Lake Michigan north of Great Lakes Naval Training Center and south of Waukegan Harbor (Figure 31). While the tableland park is heavily frequented by North Chicago residents, the 1,640-foot-long beach and bluffs have historically been underused due to limited bluff access and a community-wide fear of long-shore currents and undertow at the beach. Prior to restoration work, the shoreline at Foss Park was one of the last actively eroding sections of high bluff coast in Illinois. Sediment starvation of the littoral system caused by the breakwaters at Waukegan Harbor has resulted in accelerated beach
