Stabilization of ravines, adjacent beaches, and bluffs on Lake Michigan

ABSTRACT

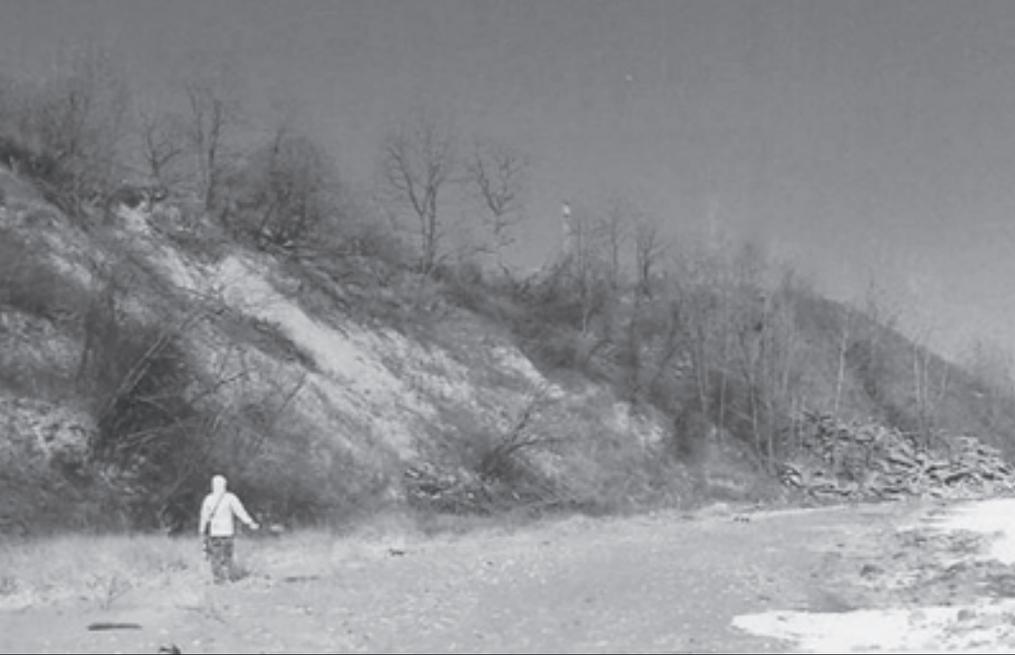
Figure 32 (top). Unrestored eroding bluff at north end of Foss Park Beach (Fall 2002 photo).

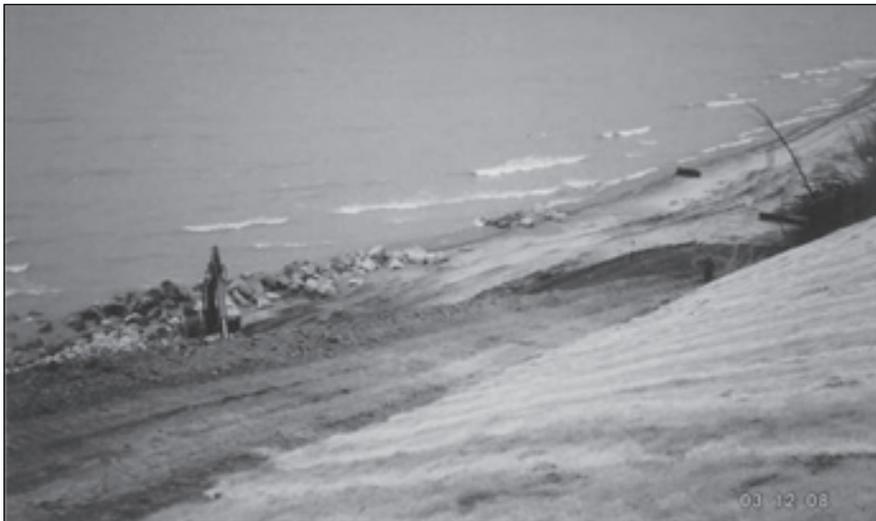
Figure 34 (bottom). Restored bluff and new perched wetland at Foss Park (lower left). Note sprouting seeds, erosion control cloth, and stone-lined swale to catch surface runoff to right of student (August 2004 photo).

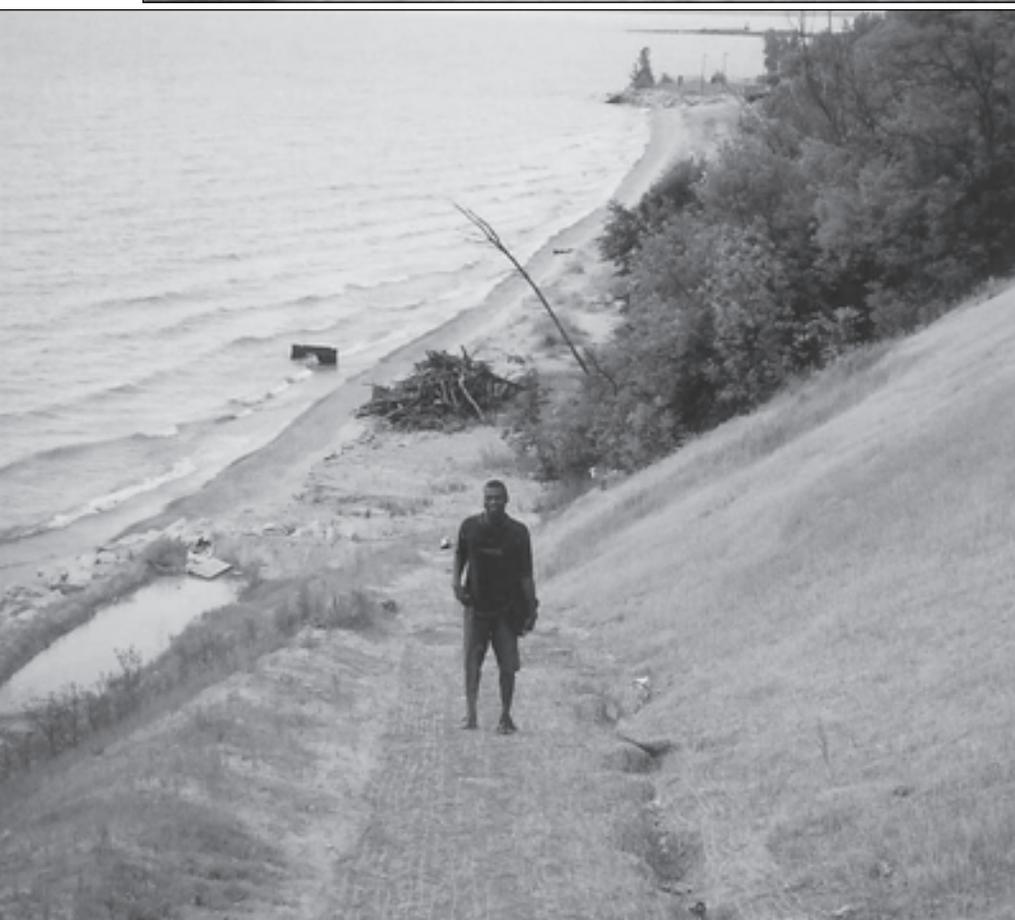
Figure 35. Perched wetland at toe of bluff, Foss Park. Seeded and plugged native plants are thriving. Invasives, including the common reed (*Phragmites australis*) and Cottonwood (*Populus deltoides*) need to be removed (Fall 2007 photo).

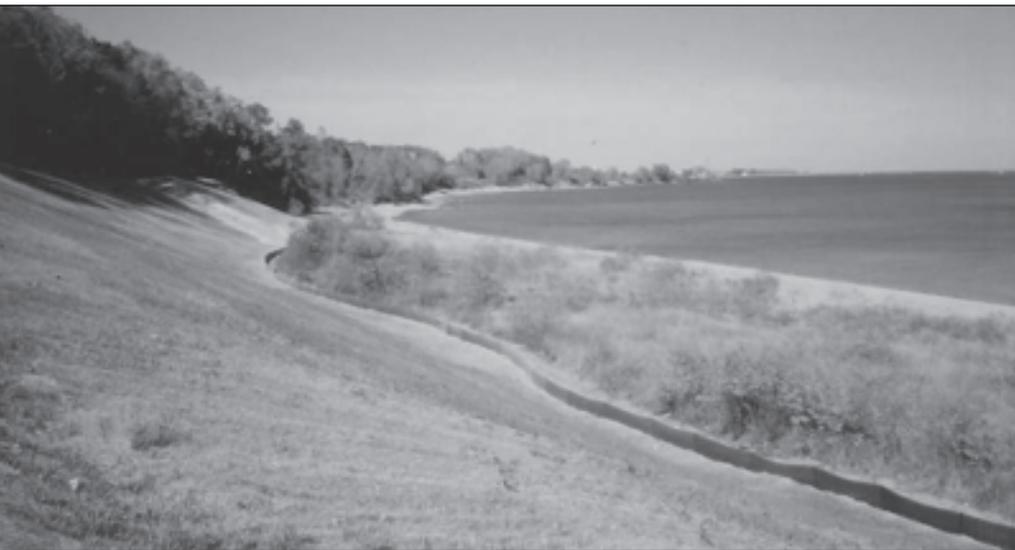
Figure 38. Ravine 10, Highland Park. This is an example of a large ravine in a highly variable state and is ranked highest (worst) in terms of erosion potential. The newly stabilized study site (lower center of air photo) is in good condition ranking five (green) in terms of channel bed stability and four (blue) for ravine bank stability. Although colors are not shown, the extremes in ravine condition are indicated by varying shades of grey. To view the color-coded ravine maps go to www.greatlakes.org/lmwep/ssip.

the greatest potential for erosion and sediment transport into Lake Michigan include: Highland Park's Ravine 10 (ranked 1 out of 47), Highland Park's Ravine 7, Highland Park's Ravine 3, and Lake Forest's Witchhazel/Seminary Ravine. These ravines scored high due to a greater number and density of stormwater and residential outlets and greater total length of unstable channels and banks. Highland Park's Ravine 4, Glencoe's Ravine 7C and Lake Forest's Clark's Ravine have the highest overall percentage of unstable bed and banks, but due to their smaller size, are ranked lower in terms of overall erosion potential as they have a higher probability for comprehensive ravine restoration. The Ravine 10 Map (Figure 38) shows typical results from the data collection and analysis.
